SURVEYOR'S CERTIFICATE  
for  
WILLIS SIFERD

The south half of Inlots Number Nine (9) and Ten (10) in the original plat of the Village of Waynesfield, and being situate in Section 18, Wayne Township, Tier 5 South, Range 8 East, Auglaize County, Ohio.

<p>STIMMEL &amp; ASSOCIATES</p> <p>167</p>	Client <u>WILLIS SIFERD &amp; JAMES KING FOR VANSCHOYCK ESI</u>
	County <u>AUGLAIZE</u> Twp. <u>WAYNE</u> Sec. <u>12</u>
	Drawn by <u>J. JAUFER</u> Scale <u>1"=50'</u> Drwg. No. <u>74-5827</u>
	Checked by _____ Date <u>3-22-74</u>
	Sheet <u>1</u> of <u>1</u> (T <u>5</u> S; R <u>8</u> E)

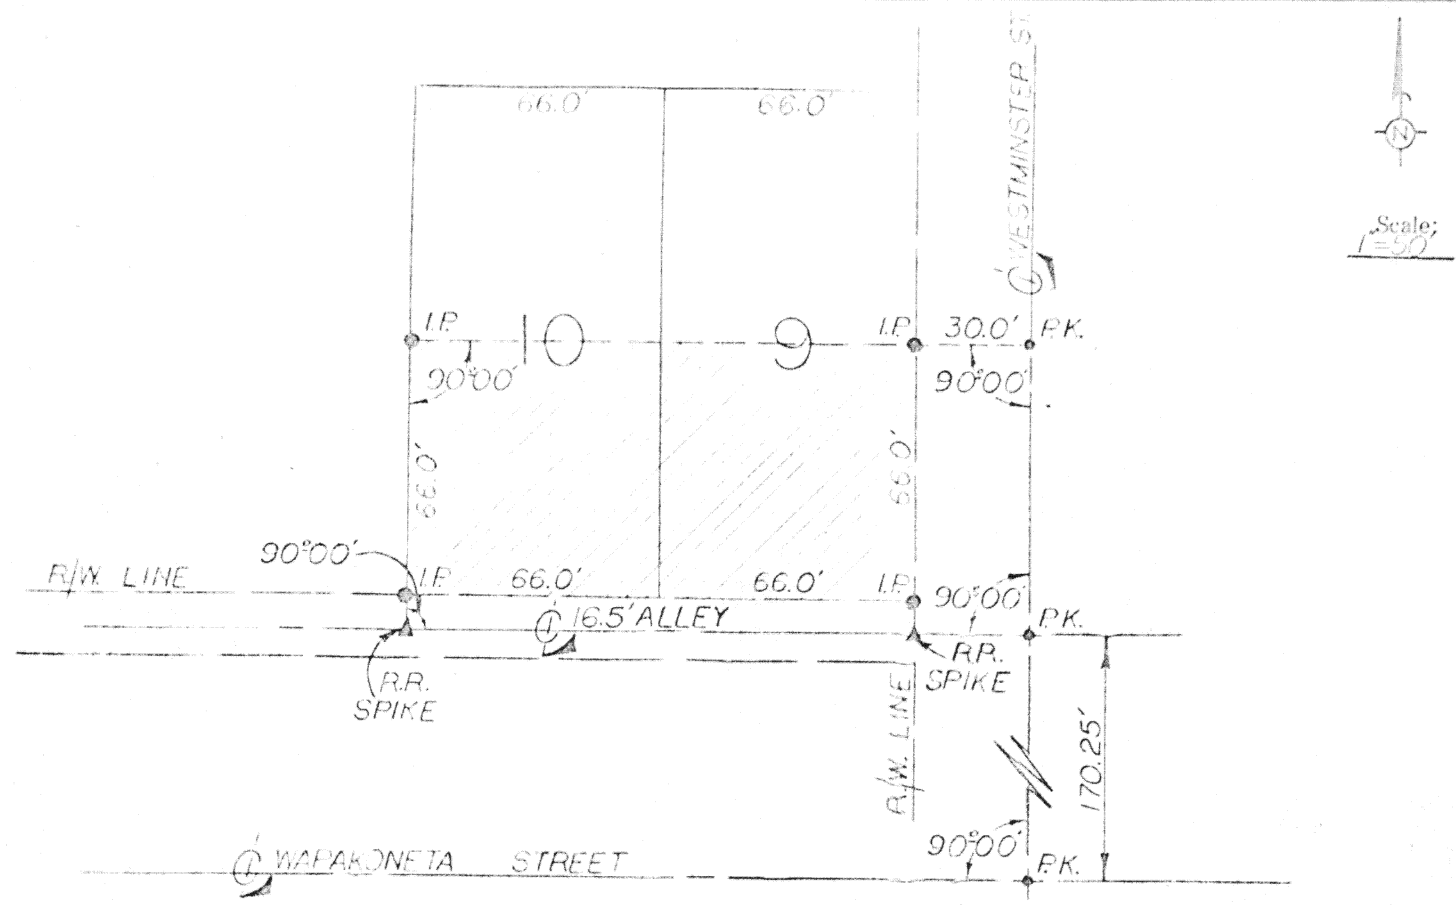
I found that the garage at the rear of the residential structure has a roof encroaching upon the alley by about 6 inches, although the foundation does not encroach.

I also found a makeshift fence on the north side of the residential structure that encroaches upon the north half of Lots 9 & 10 approximately 18 inches at its east terminus and approximately 27 inches at its western terminus.

Iron pins 5/8" in diameter by 30" lengths were left at the northwest, southwest, and southeast property corners. An iron pin is on the east-west line at the northeast corner but an old foundation kept the iron pin from being driven on the right-of-way line.
