SURVEY OF LOT #8  
HARDING SUBD #1 P.B."B" & 59  
405 SUNRISE ST.  
CRIDERSVILLE OH

Client: ROBERT OGG  
County: AUGLAIZE  
Twp.: DUCHOUQUET  
Scale: 1" = 60' DWG. NO. 1104  
Drawn by: JES  
Checked by: JES  
Date: JUNE 2 1980  
Sheet 1 of 1 (T 4 S: R 6 E)

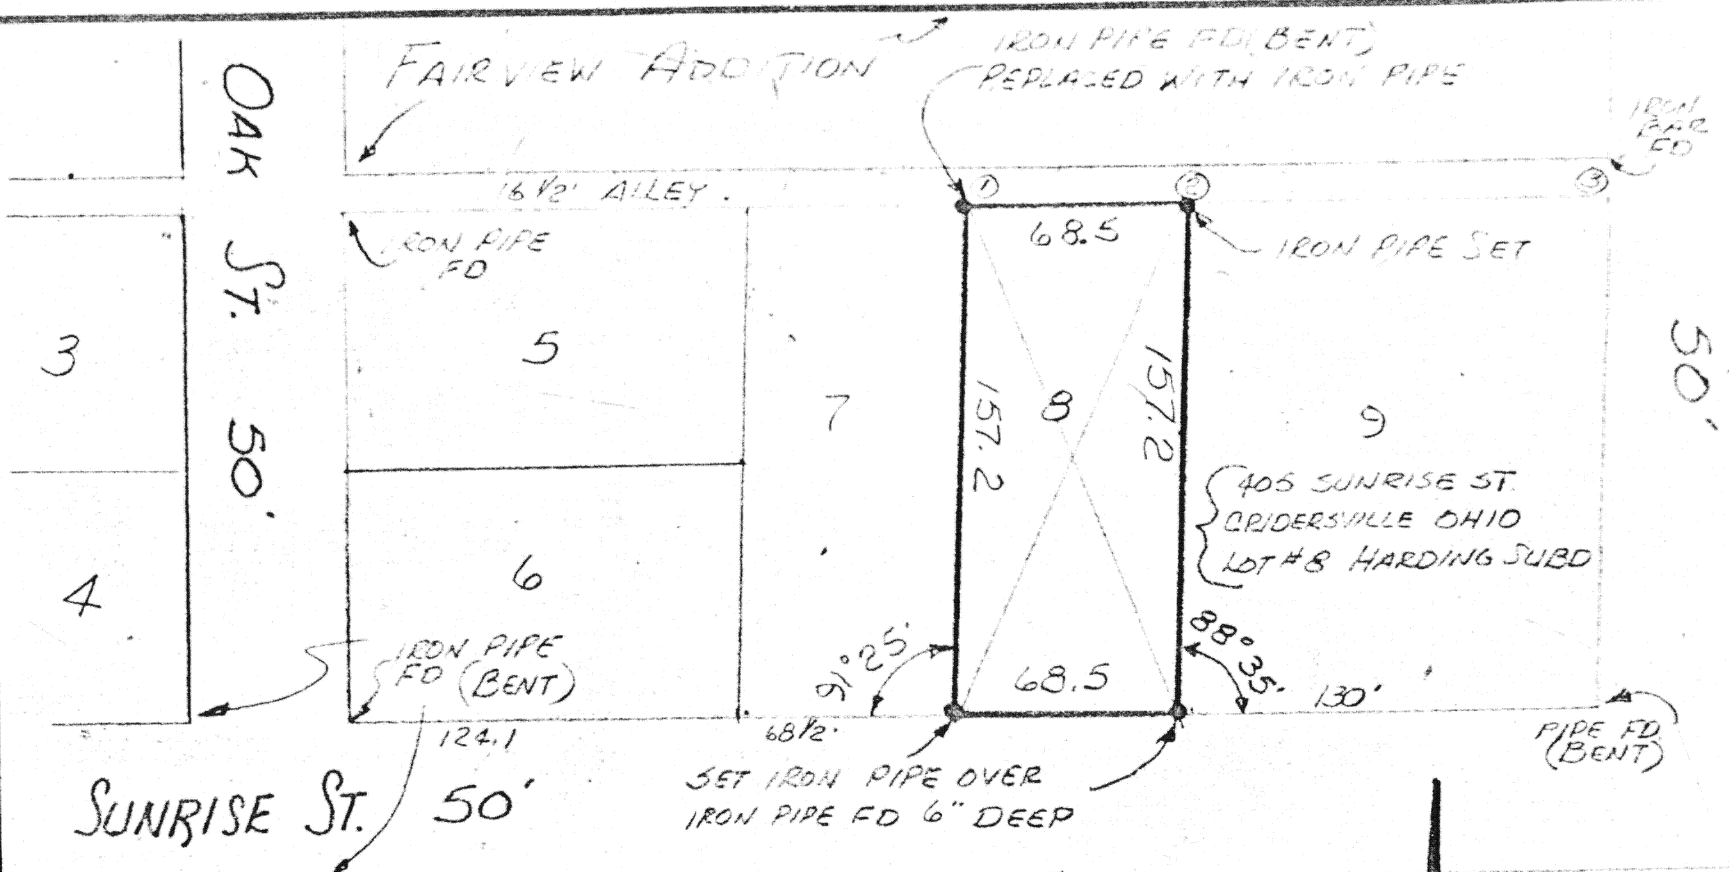
AT POINTS ①, ② & ③ ANGLE IRON POST WERE FOUND APPROX 6" EAST OF ACTUAL CORNER

NOTE: ALL OF THE IRON PINS & PIPE FOUND WERE 3" to 6" BELOW GRADE. ALL WERE CONSIDERED TO BE SET AT THE SAME TIME. AN ERROR of 0.35' E & W & 0.15' N & S EXISTS WITHIN THE PLAT. HELD CORNERS AS ORIGINALLY SET.
